Cockle Cove Creek Enterococci Source Assessment Study  
Chatham, MA

Cockle Cove Creek Enterococci  
 Source Assessment Study Area

Stakeholders Meeting  
COCKLE COVE CREEK ENTEROCOCCI SOURCE ASSESSMENT STUDY  
TOWN OF CHATHAM, MASSACHUSETTS

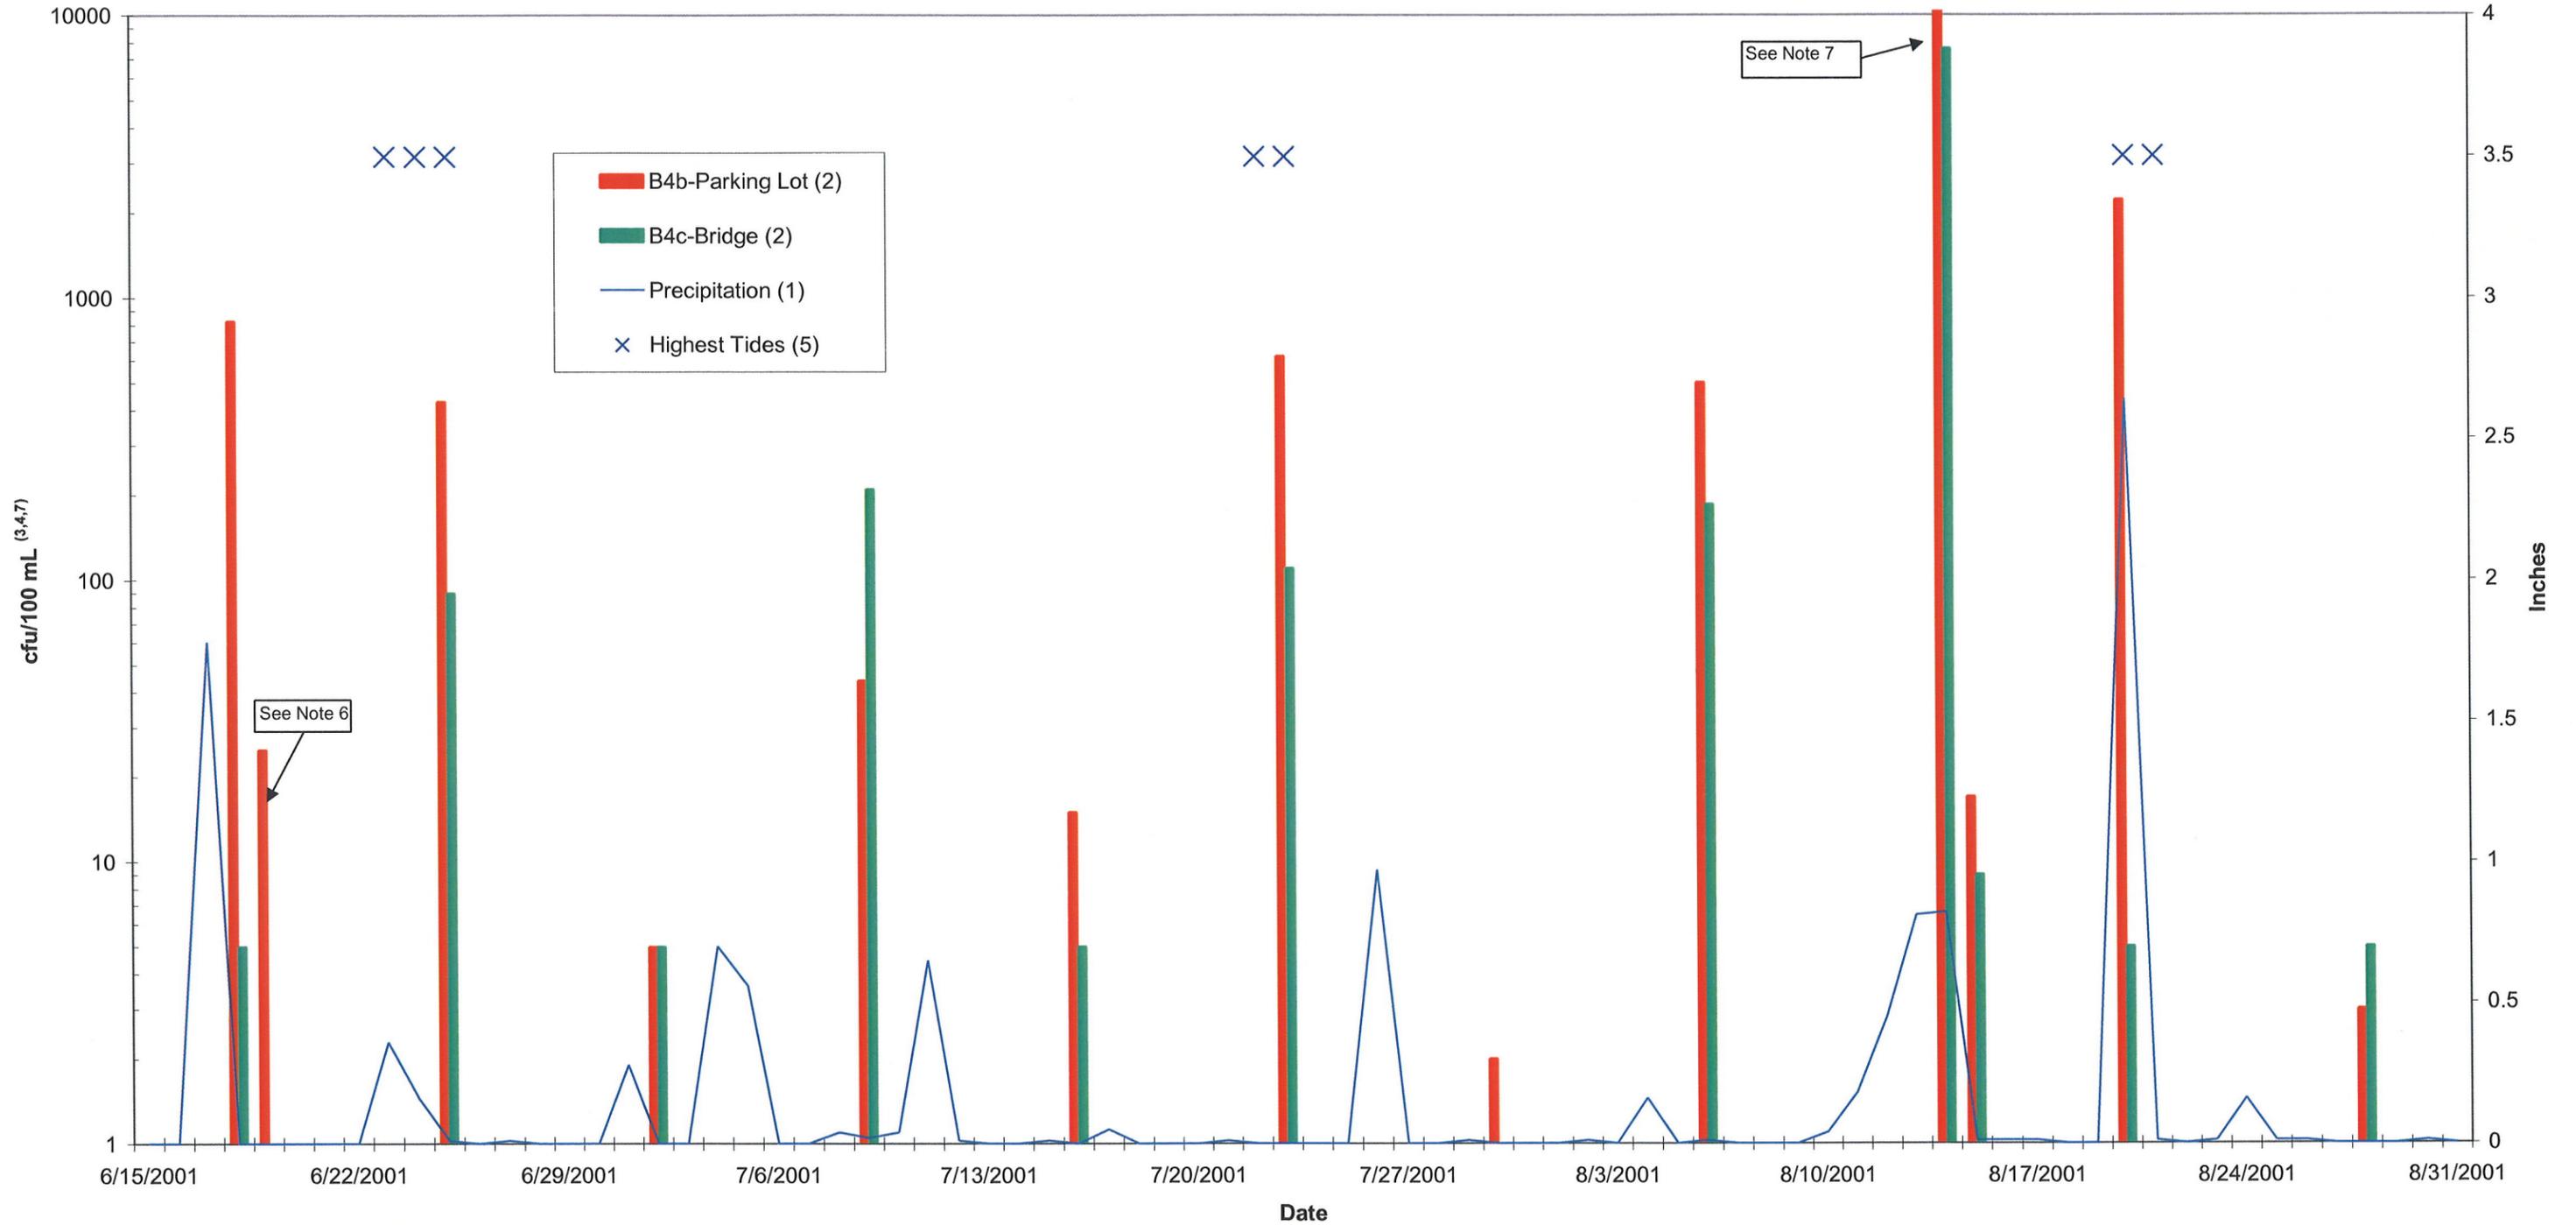
Figure 3 - 2001 Enterococci Values

1. Precipitation data based on National Oceanic and Atmospheric Administration (NOAA) data from Chatham Municipal Airport.
2. Enterococci sampling data based on Chatham Board of Health sampling results.
3. Bacteria counts recorded as Colony Forming Units per 100 milliliters (cfu/100 mL).
4. Enterococci readings of reported as less than (<\*\* cfu/100 mL) are recorded as half the reported number.
5. Tide information based on Nautical Software data for Stage Harbor.
6. B4c was not sampled on 6/19/2001. Other dates where B4c results do not appear are because the result was 1 cfu/100 ml.
7. B4b results were 13, 590 cfu/100 ml, which is beyond the scale of this graph.

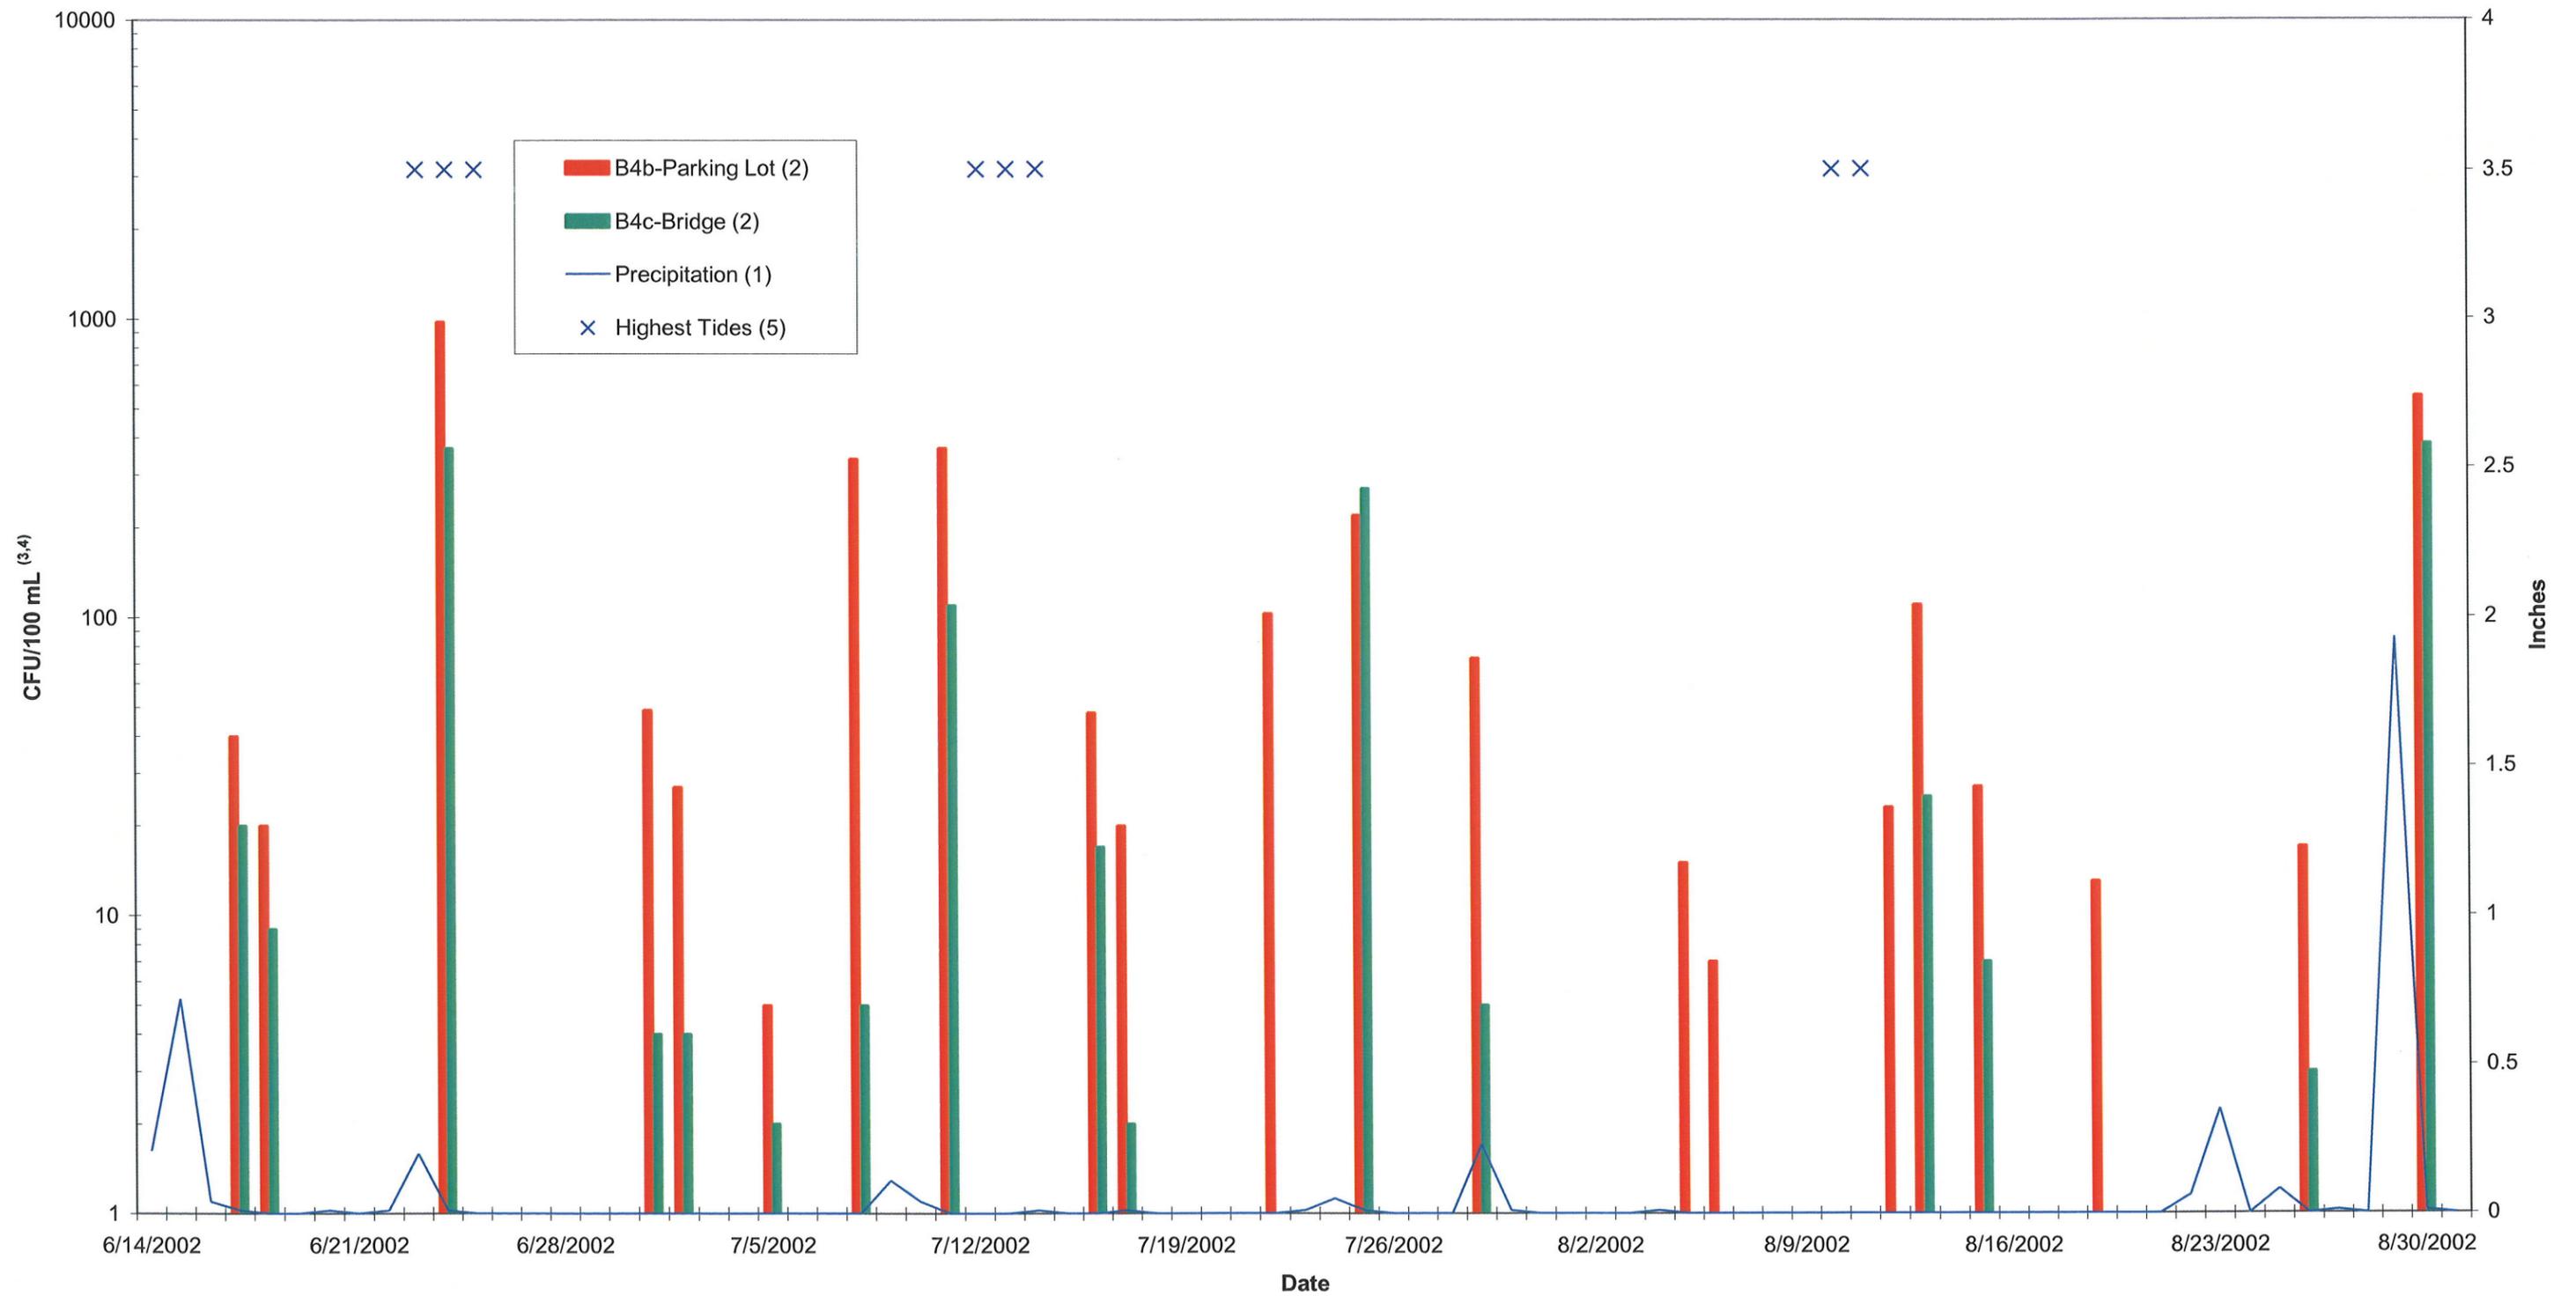
Figure 4 - 2002 Enterococci Values

1. Precipitation data based on National Oceanic and Atmospheric Administration (NOAA) data from Chatham Municipal Airport.
2. Enterococci sampling data based on Chatham Board of Health sampling results.
3. Bacteria counts recorded as Colony Forming Units per 100 milliliters (cfu/100 mL).
4. Enterococci readings of reported as less than (<\*\* cfu/100 mL) are recorded as half the reported number.
5. Tide information based on Nautical Software data for Stage Harbor.
6. Dates with no visible results for B4c are because the result was 1 cfu/100 ml.

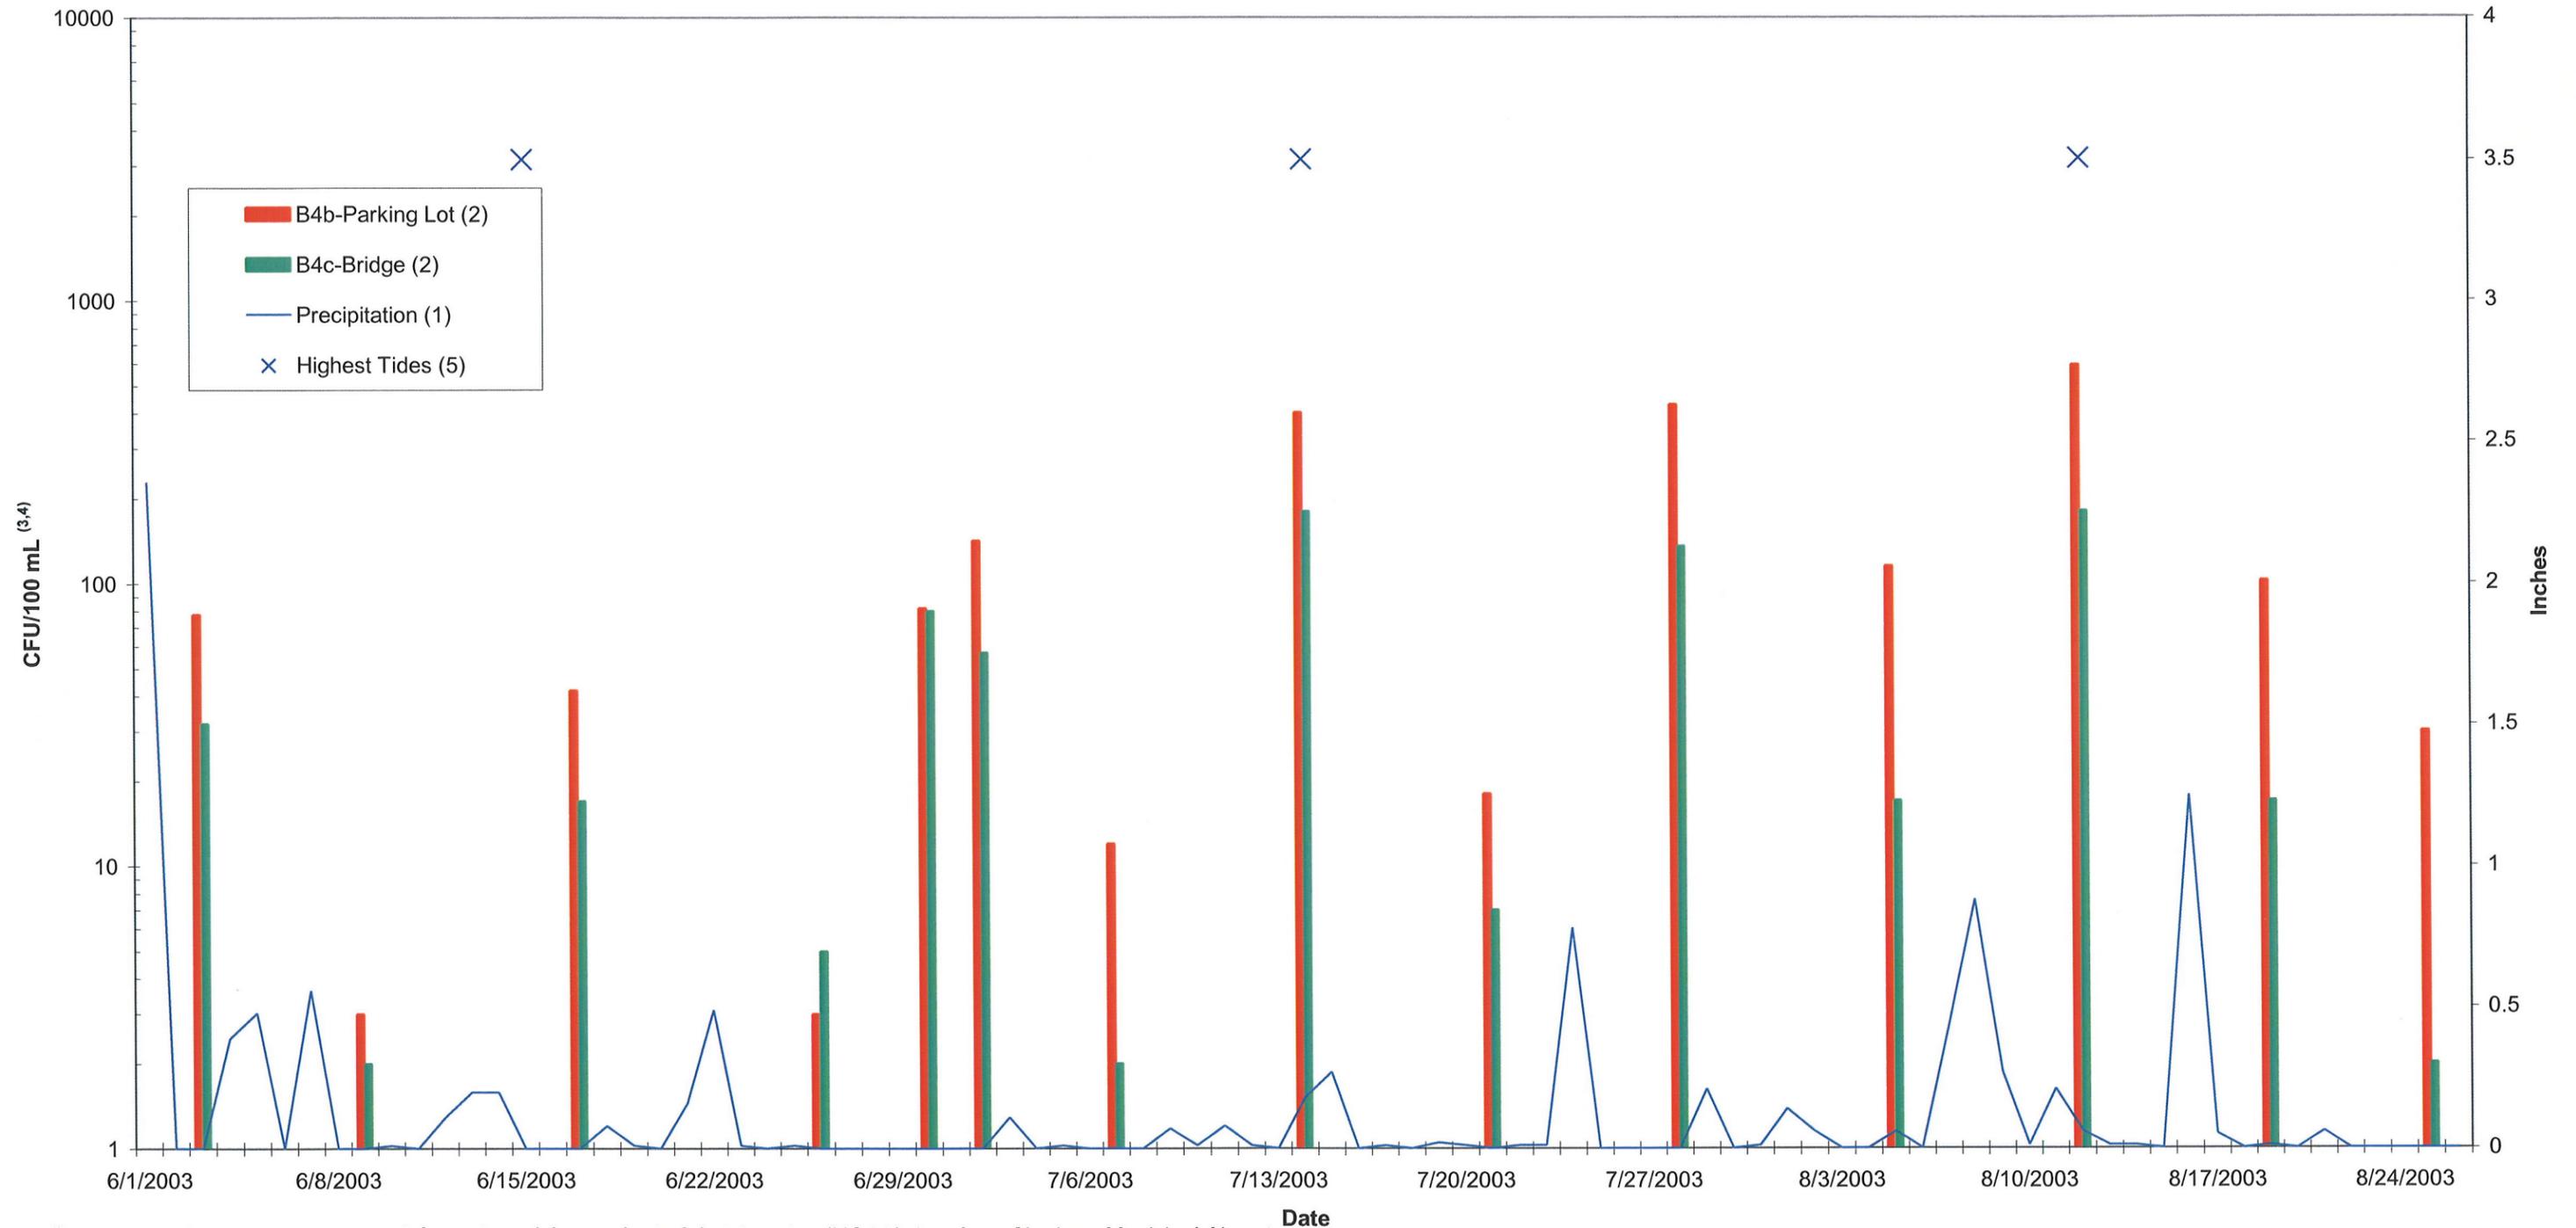
Figure 5 - 2003 Enterococci Values

1. Precipitation data based on National Oceanic and Atmospheric Administration (NOAA) data from Chatham Municipal Airport.
2. Enterococci sampling data based on Chatham Board of Health sampling results.
3. Bacteria counts recorded as Colony Forming Units per 100 milliliters (cfu/100 mL).
4. Enterococci readings of reported as less than (<\*\* cfu/100 mL) are recorded as half the reported number.
5. Tide information based on Nautical Software data for Stage Harbor.
6. Dates with no visible results for B4c are because the result was 1 cfu/100 ml.

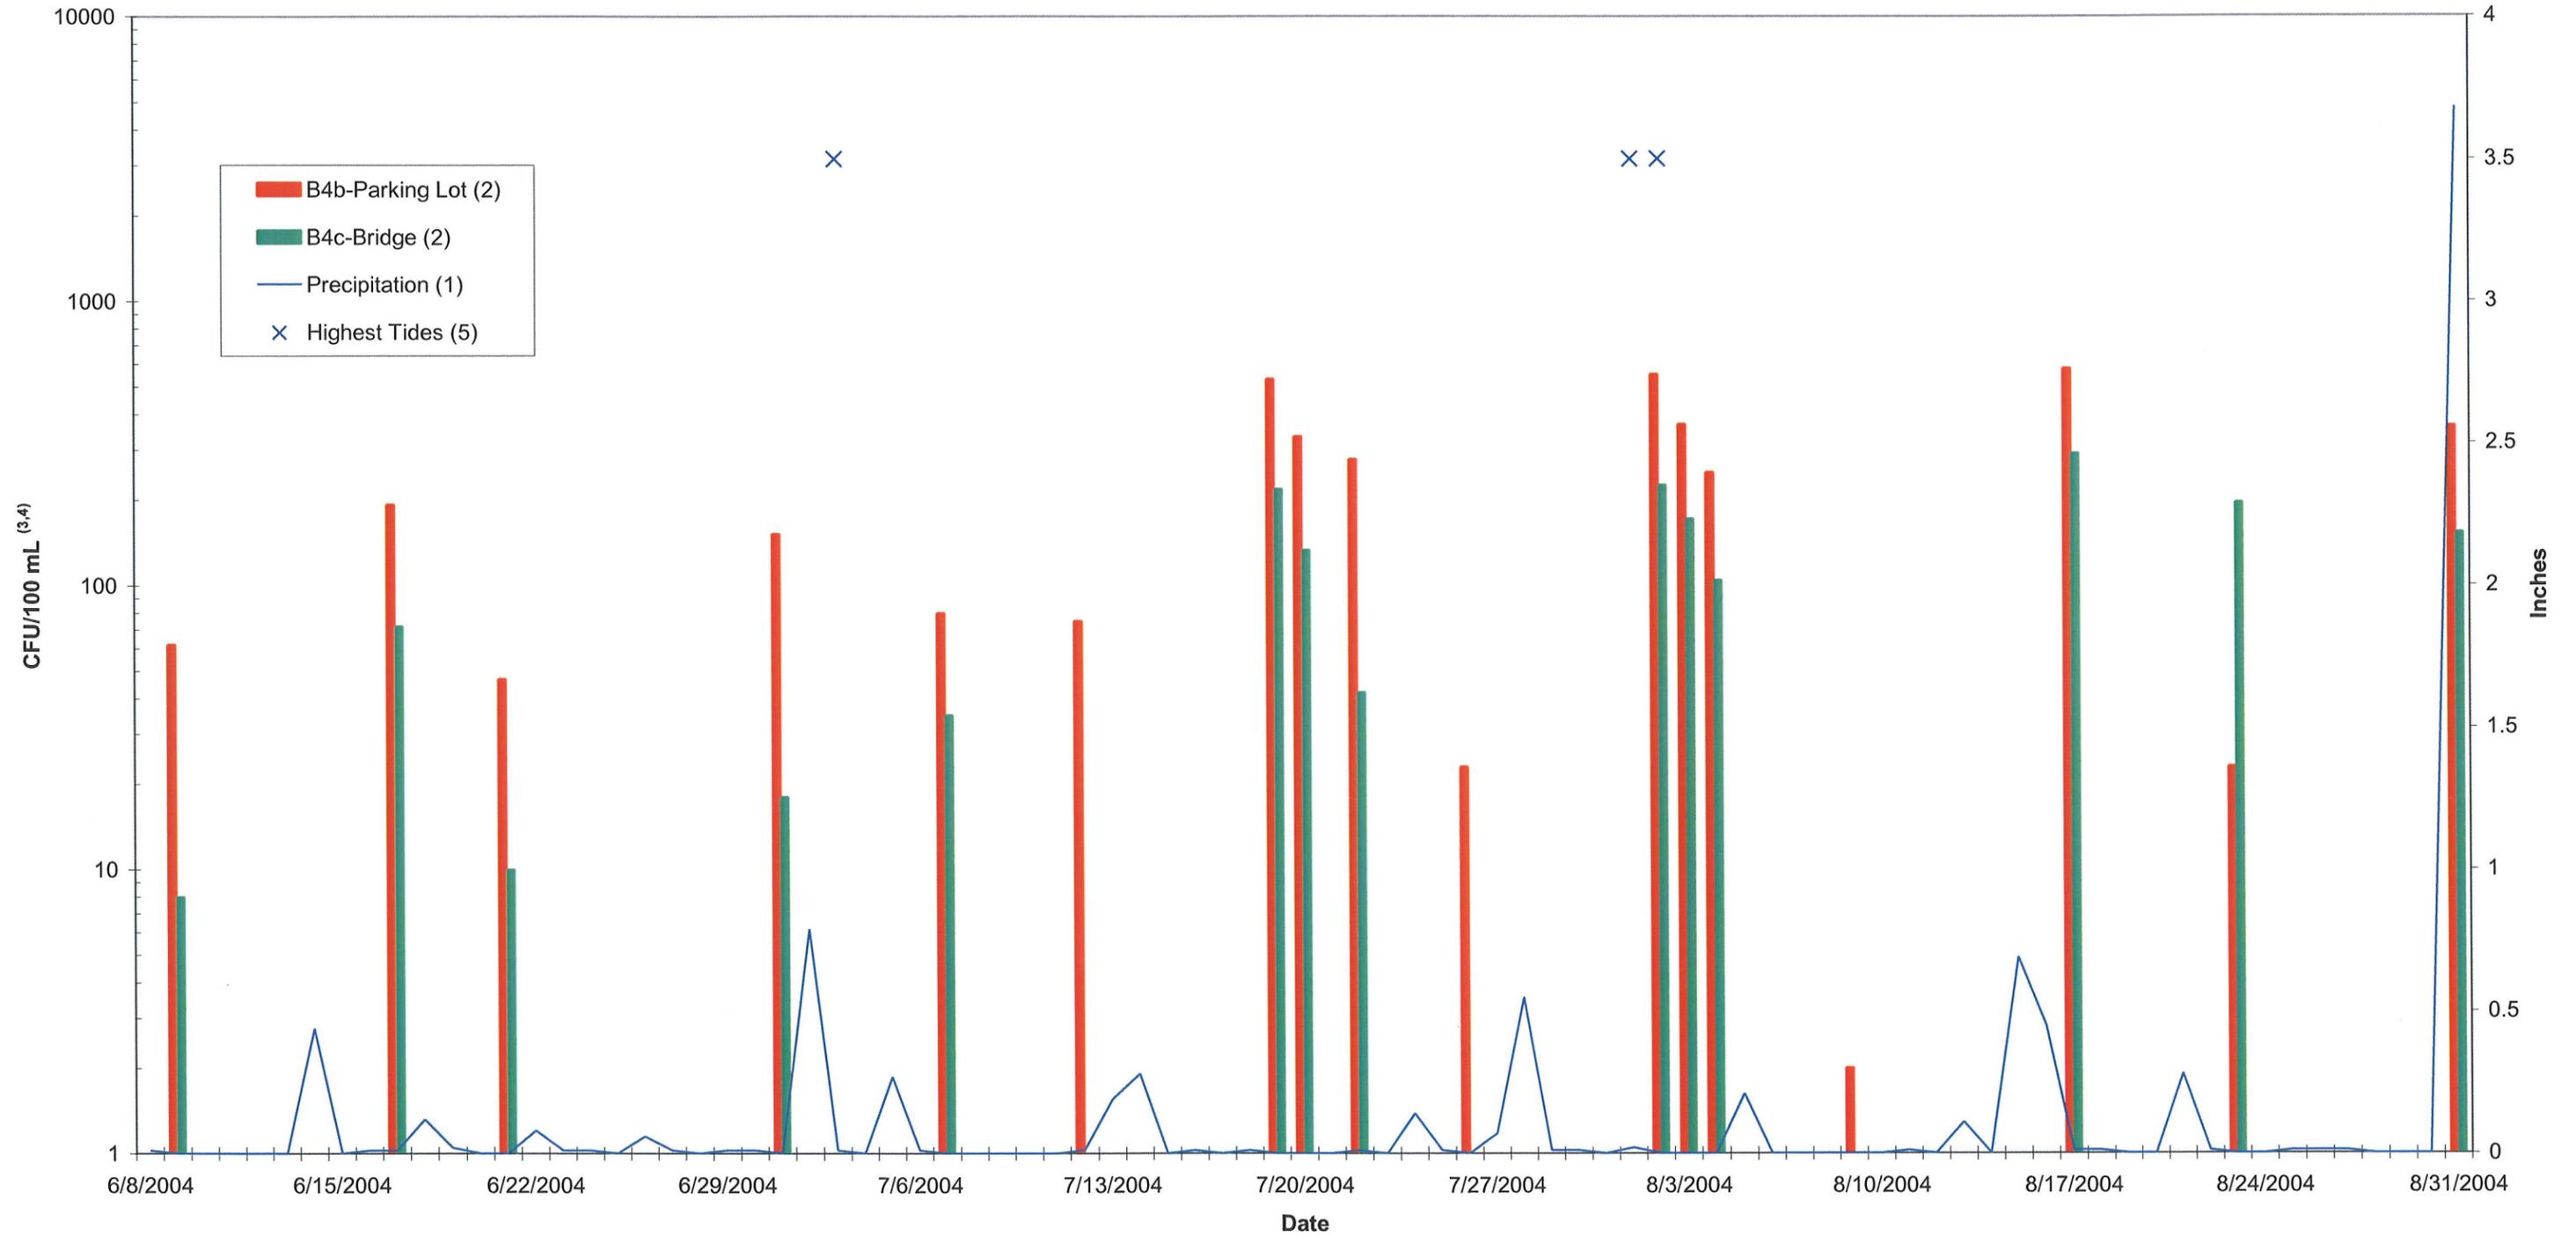
Figure 6 - 2004 Enterococci Values

1. Precipitation data based on National Oceanic and Atmospheric Administration (NOAA) data from Chatham Municipal Airport.
2. Enterococci sampling data based on Chatham Board of Health sampling results.
3. Bacteria counts recorded as Colony Forming Units per 100 milliliters (cfu/100 mL).
4. Enterococci readings of reported as less than (<\*\* cfu/100 mL) are recorded as half the reported number.
5. Tide information based on Nautical Software data for Stage Harbor.
6. Dates with no visible results for B4c are because the result was 1 cfu/100 ml.

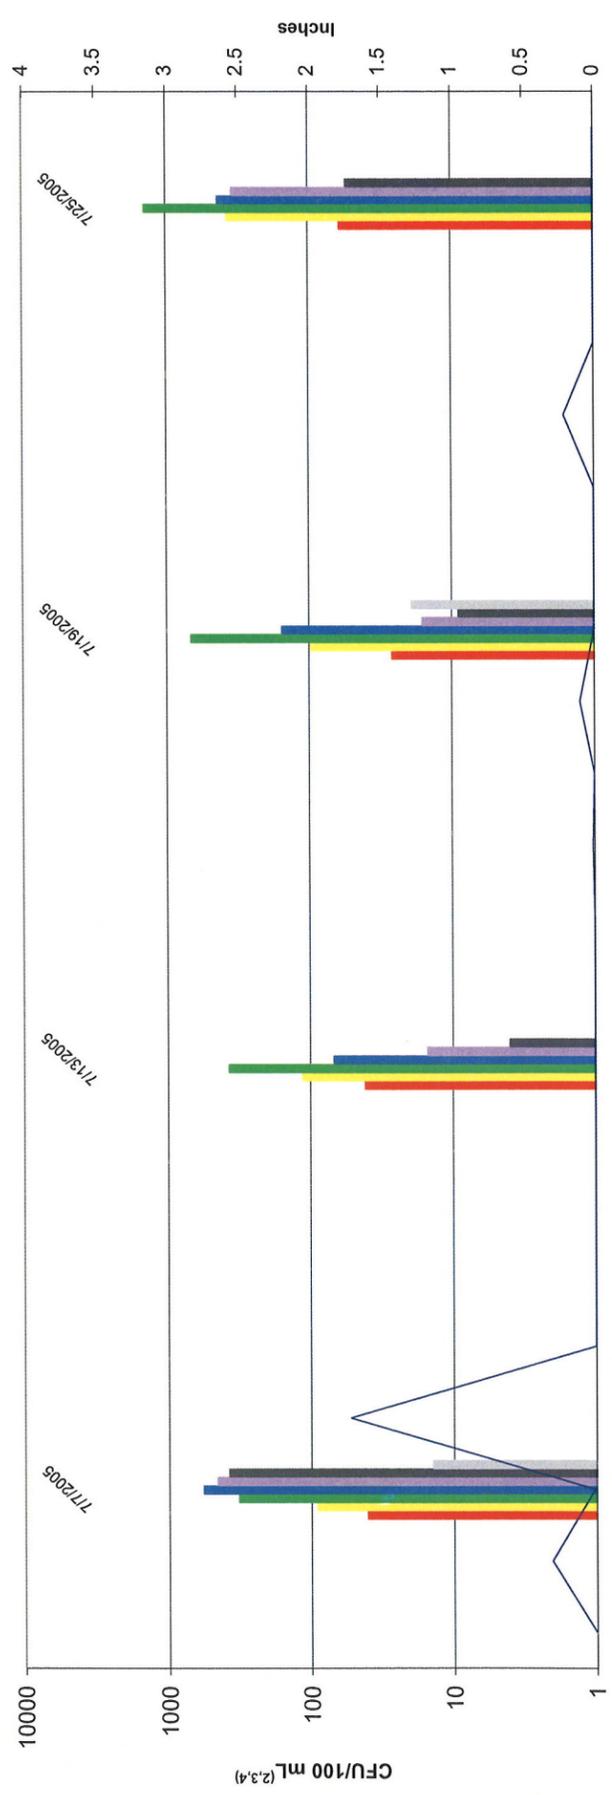
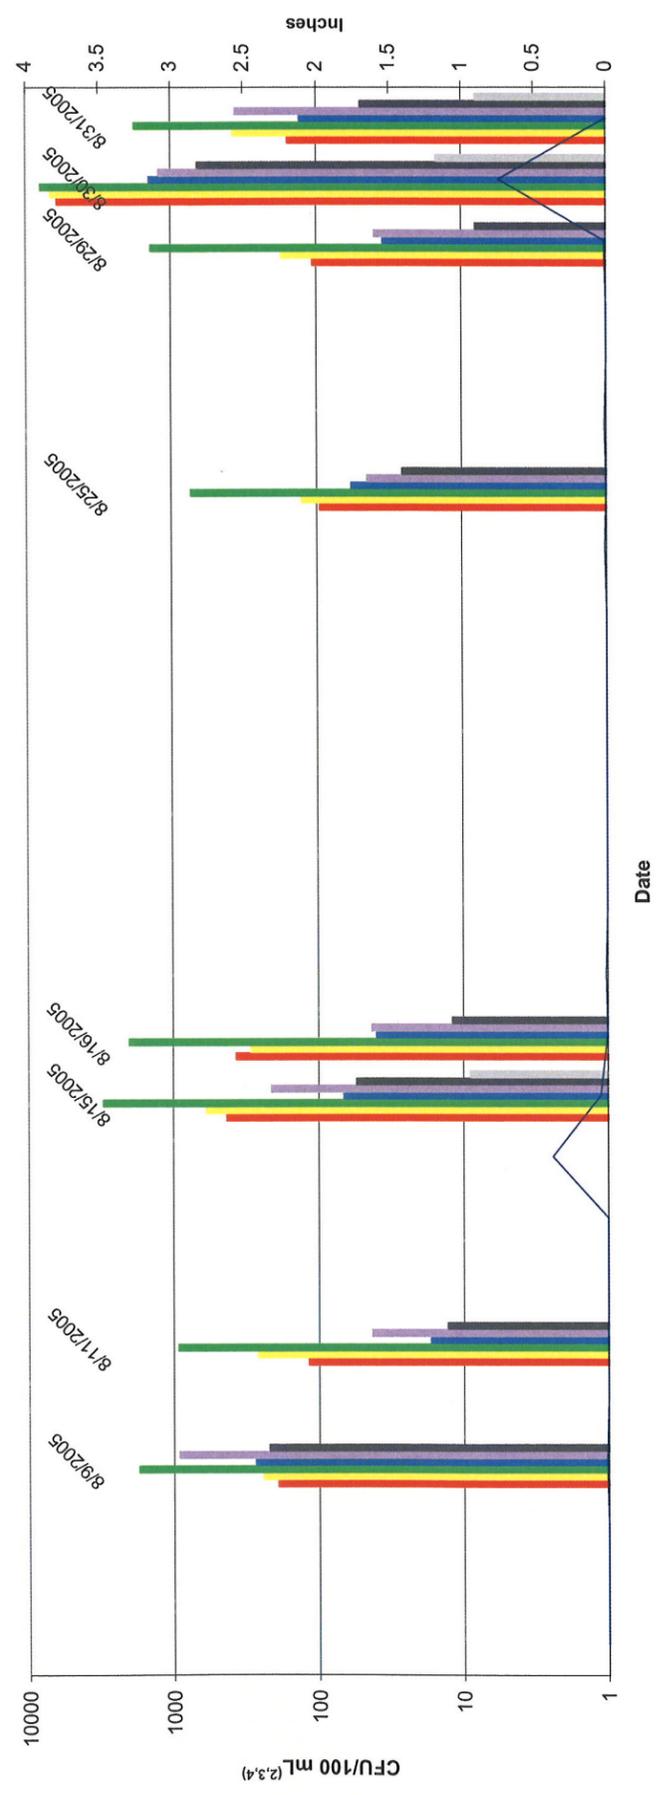
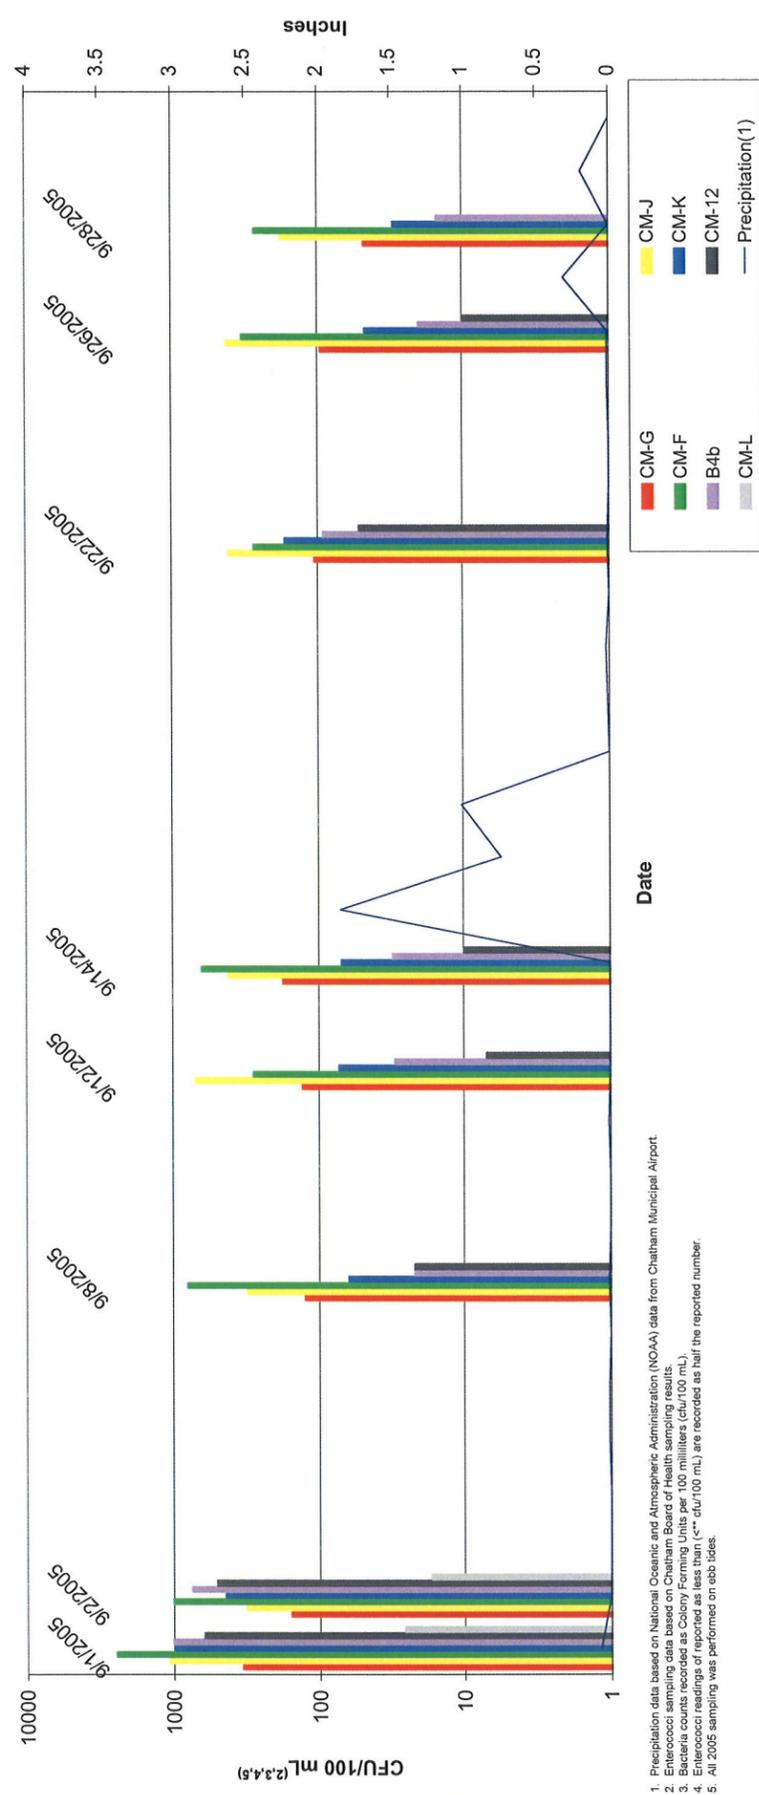
Figure 8 - Enterococci Sampling Events and Rain Events

1. Precipitation data based on National Oceanic and Atmospheric Administration (NOAA) data from Chatham Municipal Airport.  
 2. Enterococci sampling data based on Chatham Board of Health sampling results.  
 3. Bacteria counts recorded as Colony Forming Units per 100 milliliters (cfu/100 mL).  
 4. Enterococci readings of reported as less than (<) cfu/100 mL are recorded as half the reported number.  
 5. All 2005 sampling was performed on odd tides.

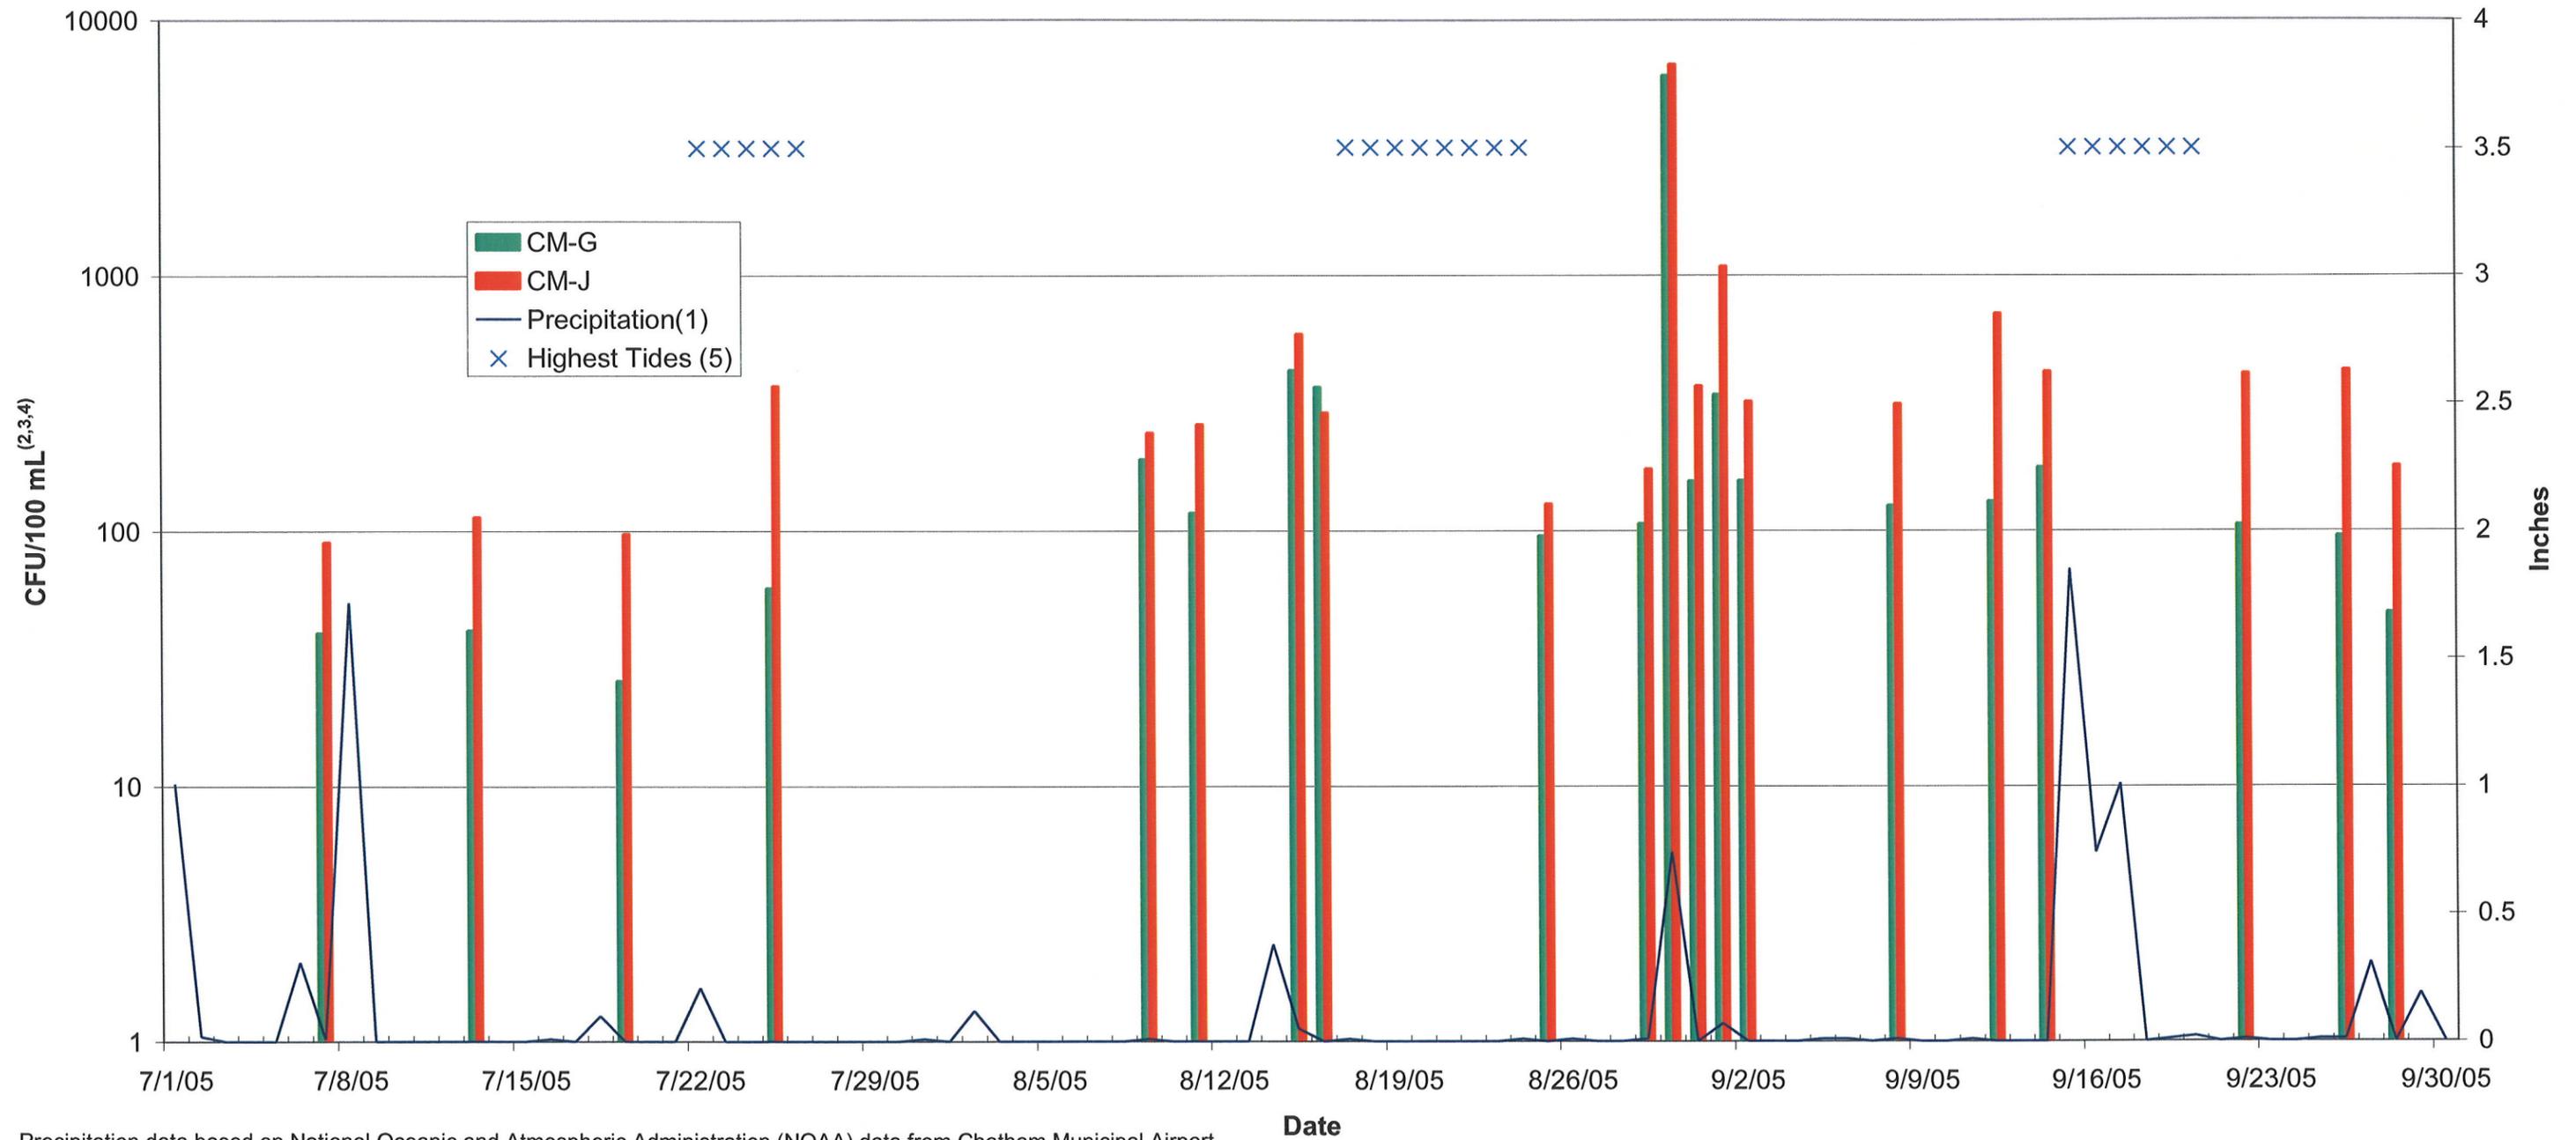
Figure 9 - 2005 Upper Creek

1. Precipitation data based on National Oceanic and Atmospheric Administration (NOAA) data from Chatham Municipal Airport.
2. Enterococci sampling data based on Chatham Board of Health sampling results.
3. Bacteria counts recorded as Colony Forming Units per 100 milliliters (cfu/100 mL).
4. Enterococci readings of reported as less than (<\*\* cfu/100 mL) are recorded as half the reported number.
5. Tide information based on Nautical Software data for Stage Harbor.
6. All 2005 sampling was performed on ebb tides.
