Cockle Cove Creek Enterococci Source Assessment Study  
Chatham, MA

Cockle Cove Creek Enterococci  
 Source Assessment Study Area

Stakeholders Meeting  
COCKLE COVE CREEK ENTEROCOCCI SOURCE ASSESSMENT STUDY  
TOWN OF CHATHAM, MASSACHUSETTS

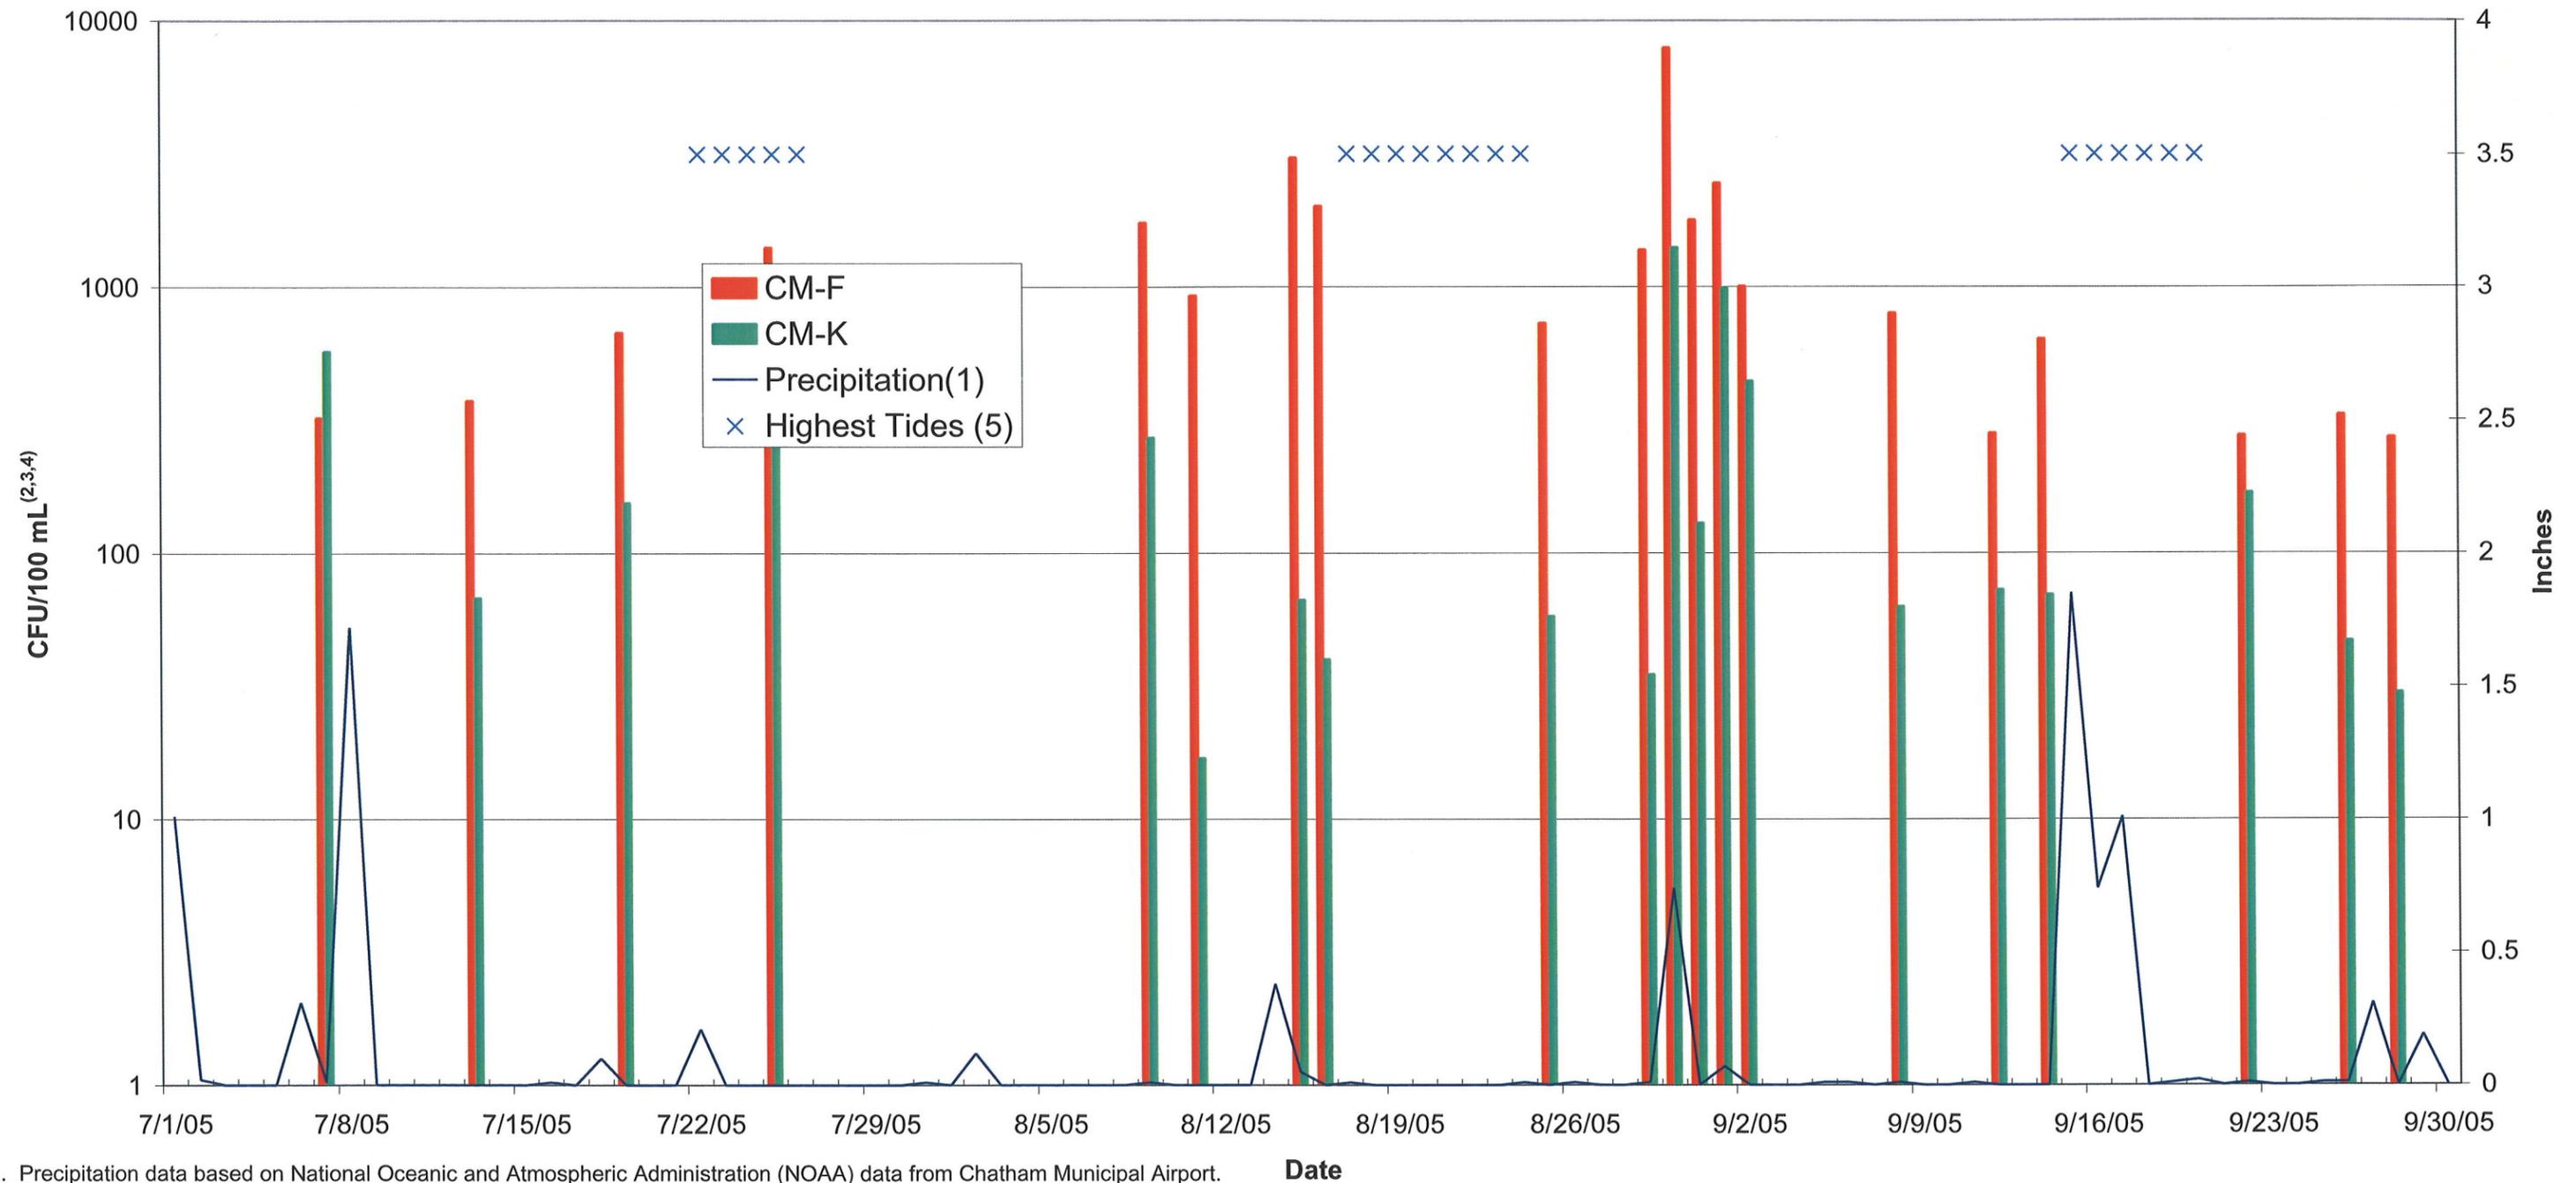
Figure 10 - 2005 Mid Creek

1. Precipitation data based on National Oceanic and Atmospheric Administration (NOAA) data from Chatham Municipal Airport.
2. Enterococci sampling data based on Chatham Board of Health sampling results.
3. Bacteria counts recorded as Colony Forming Units per 100 milliliters (cfu/100 mL).
4. Enterococci readings of reported as less than (<\*\* cfu/100 mL) are recorded as half the reported number.
5. Tide information based on Nautical Software data for Stage Harbor.
6. All 2005 sampling was performed on ebb tides.

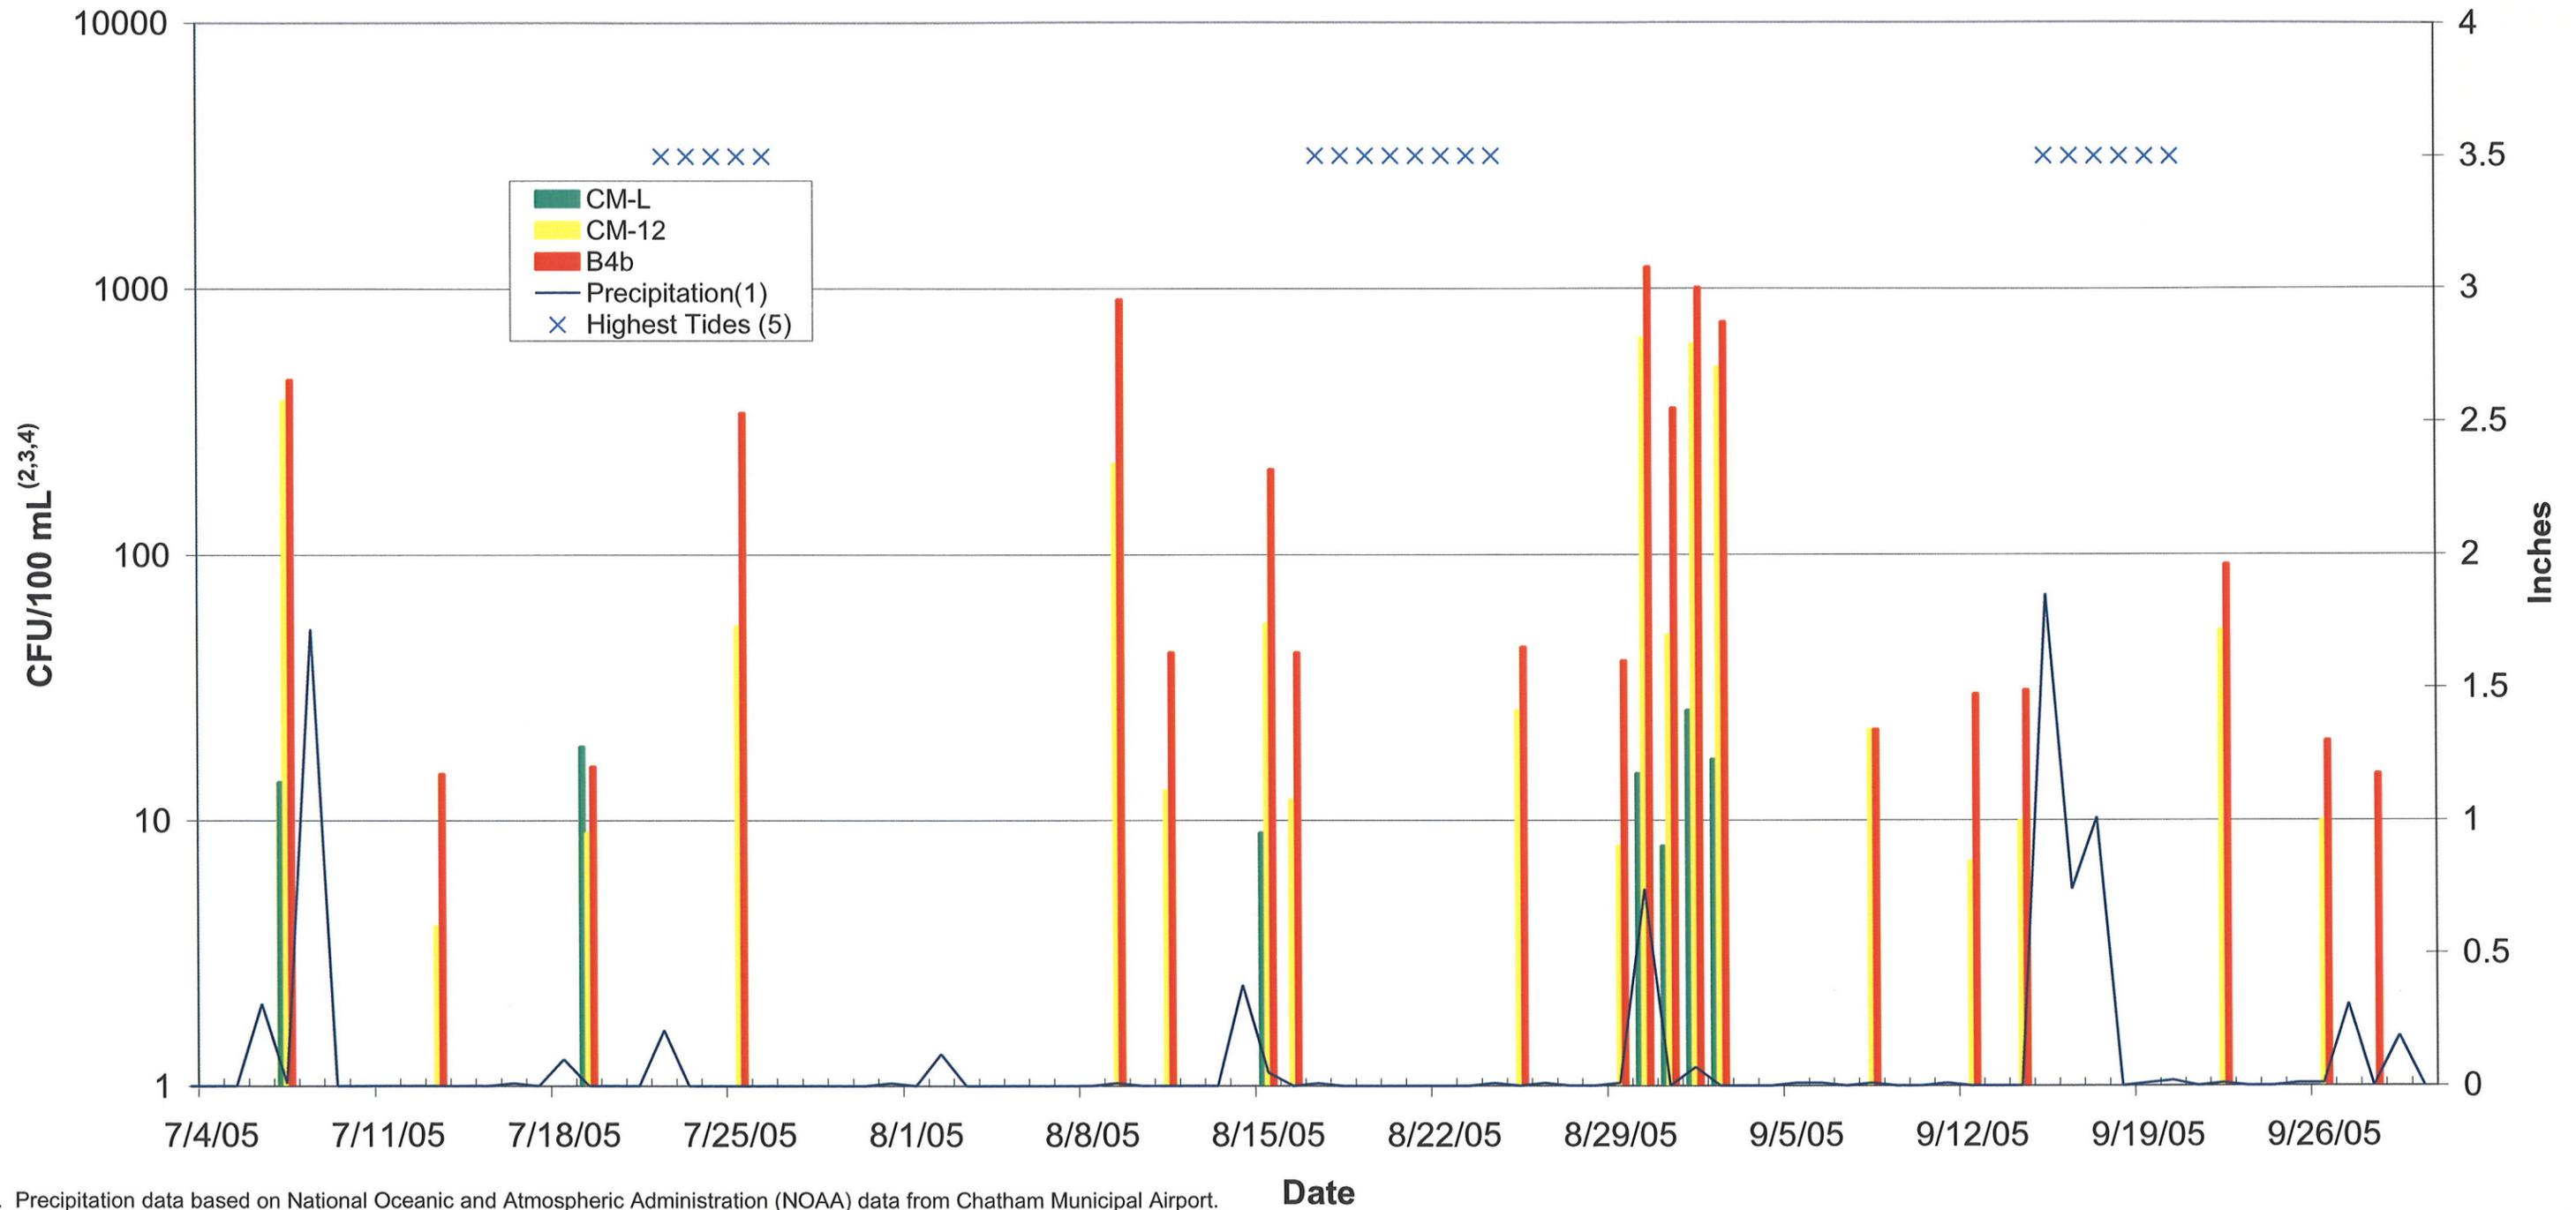
Figure 11 - 2005 Lower Creek

1. Precipitation data based on National Oceanic and Atmospheric Administration (NOAA) data from Chatham Municipal Airport.
2. Enterococci sampling data based on Chatham Board of Health sampling results.
3. Bacteria counts recorded as Colony Forming Units per 100 milliliters (cfu/100 mL).
4. Enterococci readings of reported as less than (<\*\* cfu/100 mL) are recorded as half the reported number.
5. Tide information based on Nautical Software data for Stage Harbor.
6. All 2005 sampling was performed on ebb tides.

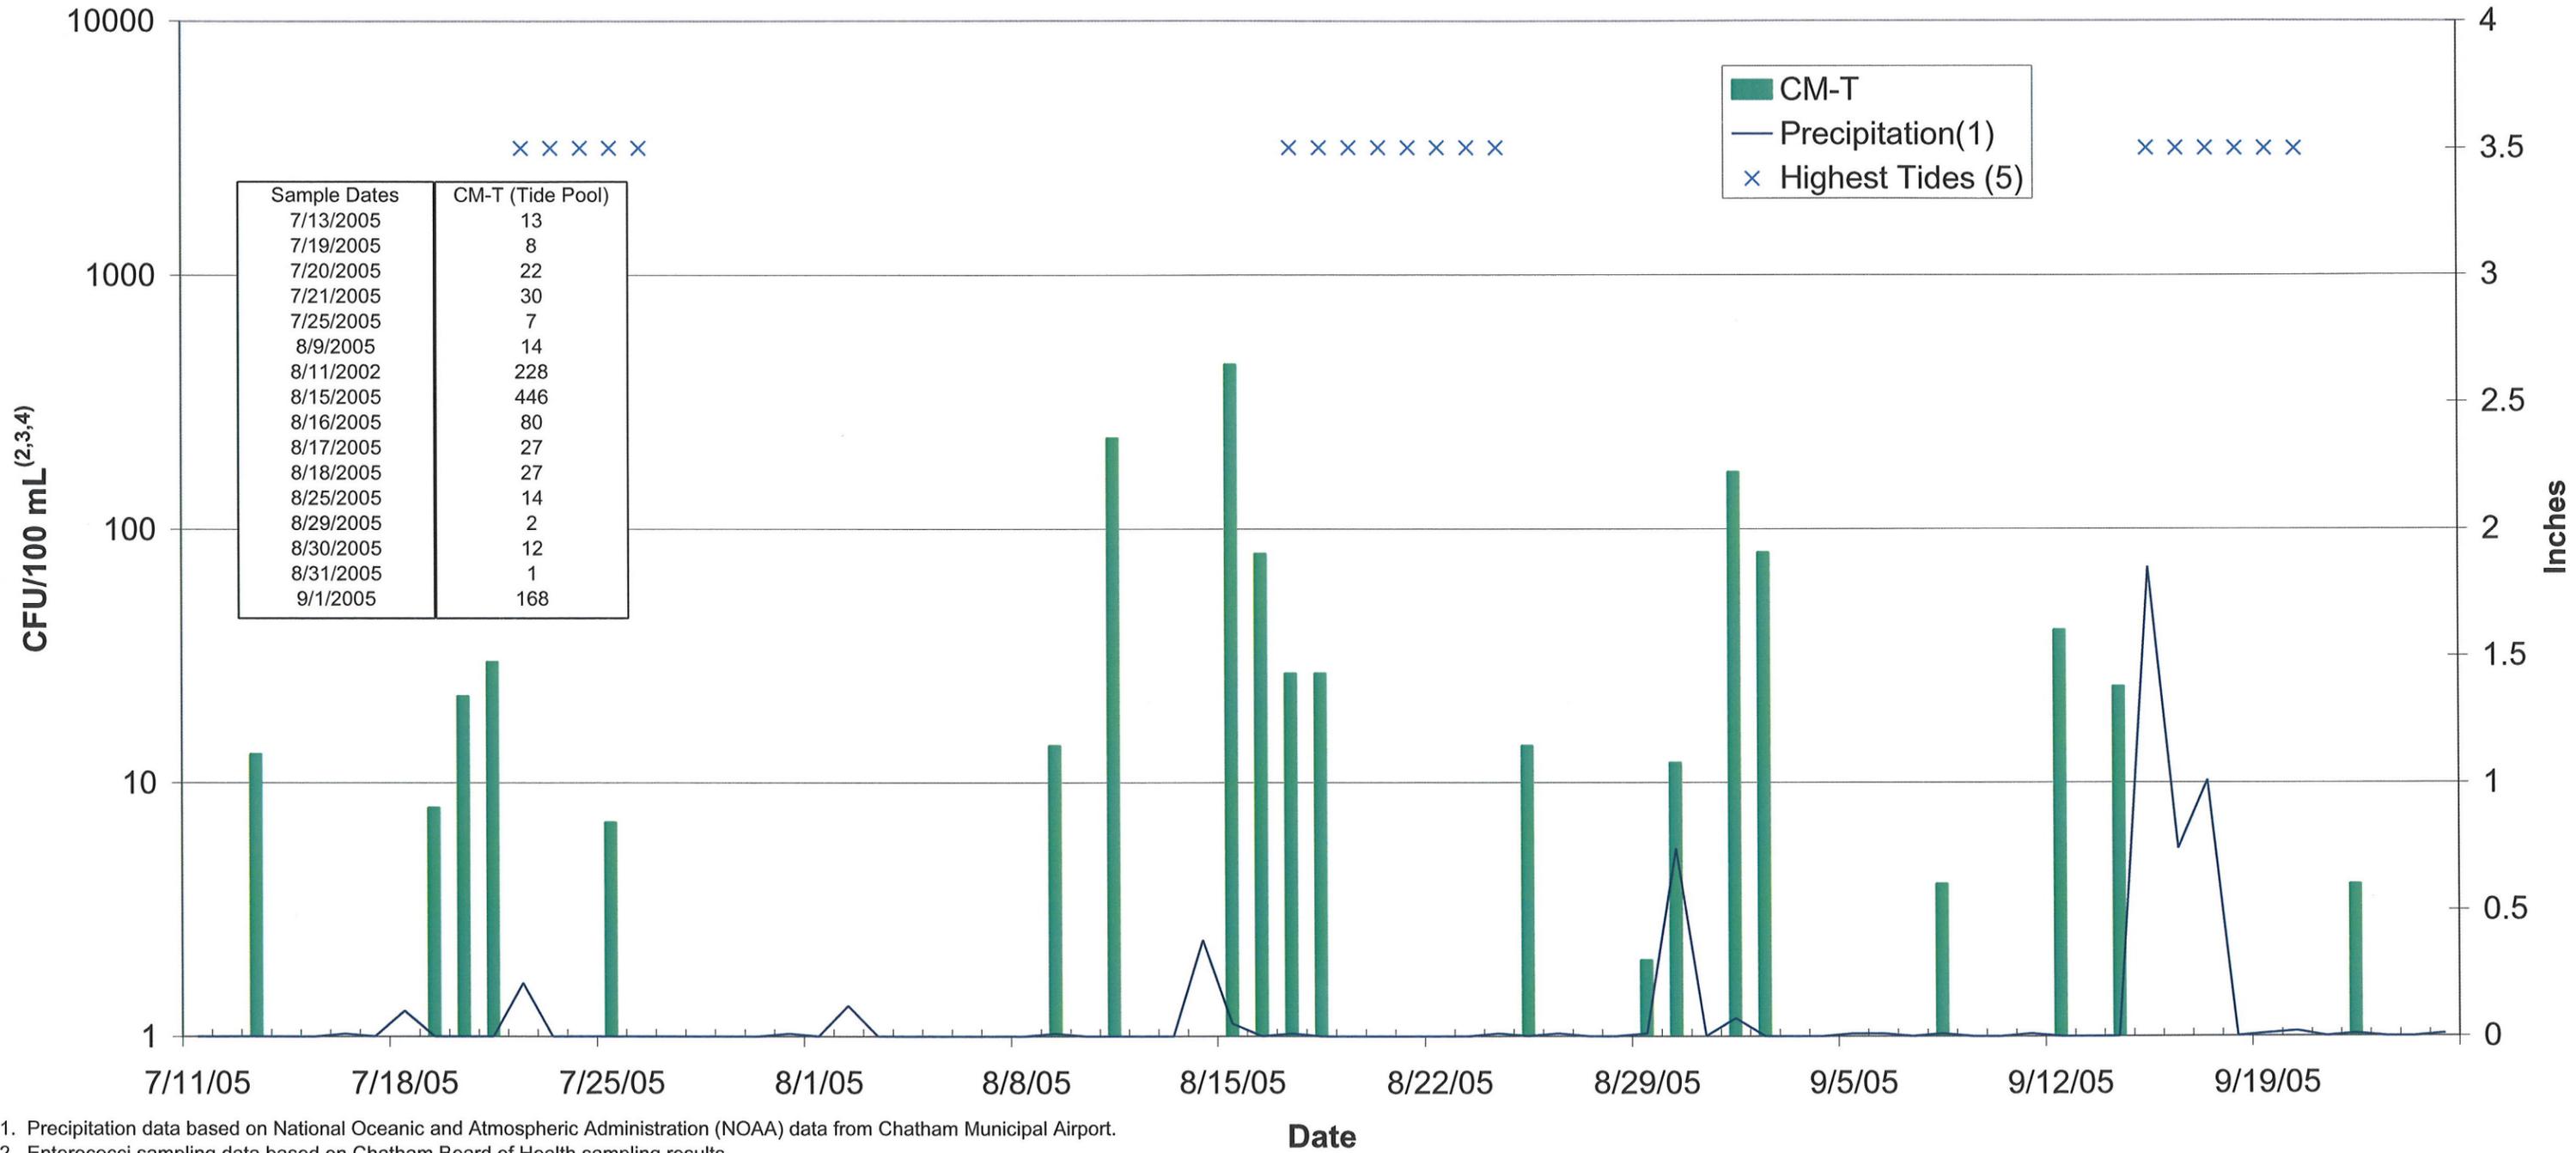
Figure 12 - 2005 Tide Pool

1. Precipitation data based on National Oceanic and Atmospheric Administration (NOAA) data from Chatham Municipal Airport.
2. Enterococci sampling data based on Chatham Board of Health sampling results.
3. Bacteria counts recorded as Colony Forming Units per 100 milliliters (cfu/100 mL).
4. Enterococci readings of reported as less than (<\*\* cfu/100 mL) are recorded as half the reported number.
5. Tide information based on Nautical Software data for Stage Harbor. Cockle Cove Creek's tides are approximately 2 hours behind Stage Harbor tides.
6. All 2005 sampling was performed on ebb tides.
7. Tide pool data is shown separate from other sampling data for clarity and because the tide pool was not sampled on exactly the same schedule.

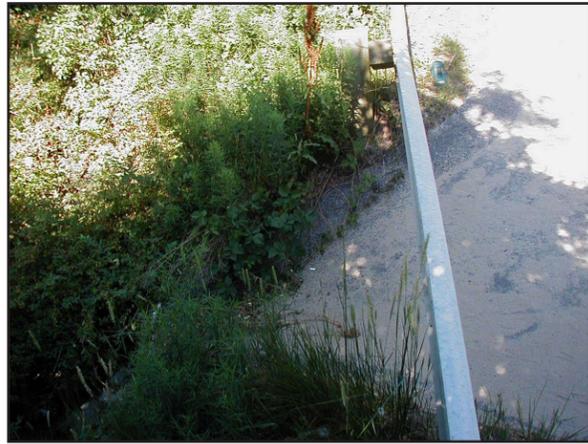
Paved Stormwater Swale on Route 28

- Improved stormwater facilities should be implemented to reduce the existing discharges from road runoff. Route 28 is the primary source of road runoff to the Cockle Cove Creek watershed. The Massachusetts Highway Department should be encouraged to replace an existing paved swale with catchbasins and leaching facilities capable of containing the first flush of stormwater runoff.
- Construction of a fresh water pond in the upper portion of Cockle Cove Creek may be considered. The pond would improve water quality by preventing the stormwater from flowing directly into Cockle Cove Creek, allowing infiltration of the stormwater.

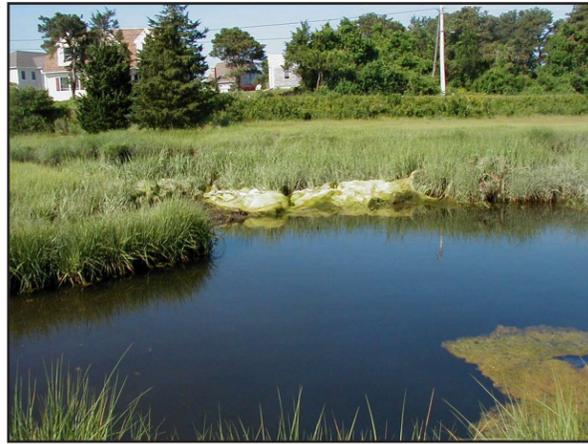
Accumulated Algal Wrack

5. Natural sources, such as wildlife activity and accumulation of wrack material, were considered to be the primary source of the elevated enterococci levels.

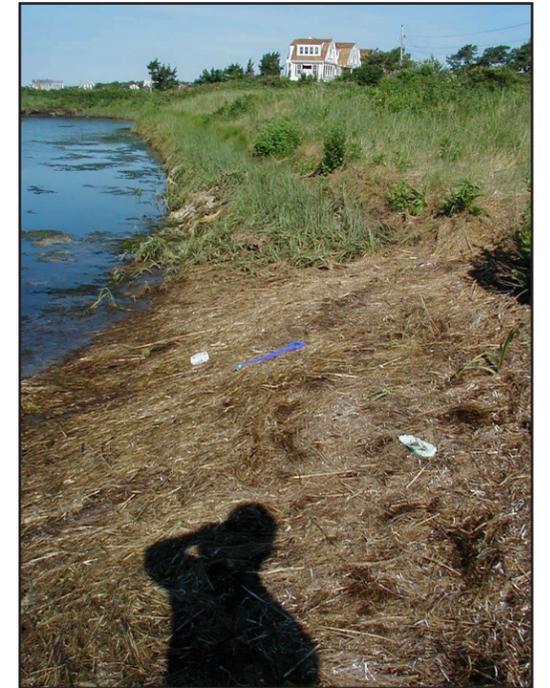
Accumulated Wrack
