*Town of Chatham, Massachusetts*  
***Bacterial Source Assessment for a  
Wetland-Dominated Watershed:***  
*Guidance Document and Case Study Report*

*December 2005*

# BACTERIAL SOURCE ASSESSMENT FOR A WETLAND-DOMINATED WATERSHED: GUIDANCE DOCUMENT AND CASE STUDY REPORT

## CHATHAM, MA

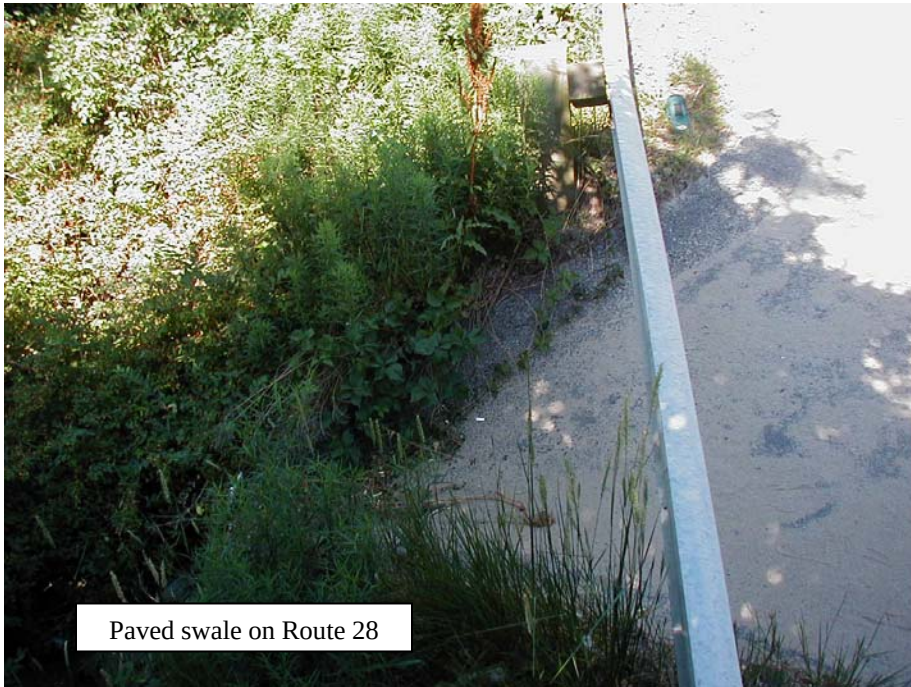
Paved swale on Route 28

The second site walk again showed no evidence of stormwater discharge pipes. However, it was noted that a paved swale on Route 28 directs stormwater runoff into the northern end of the abandoned cranberry bog (see picture at left). Upon inspection, it was noted that the swale discharges into a dry area at the head of the abandoned cranberry bog. Stormwater runoff has a fairly long distance to travel over densely wooded land

before reaching Cockle Cove Creek's waters. The paved swale along Route 28 was the only stormwater source for which runoff calculations were performed.

No stormwater discharge pipes were observed during the site walks. The paved swale on Route 28 was the only direct discharge of stormwater runoff into the marsh system. As mentioned, this discharge is in the upper end of the marsh (the abandoned cranberry bog), and any stormwater runoff must travel over densely vegetated land before reaching surface waters. Additionally, catchbasins along Route 28 direct a large portion of the stormwater from Route 28 to a discharge pipe on the northern side of the road. A culvert under Route 28 connects the wetlands on the northern side of Route 28 to the Cockle Cove Creek marsh system. However, this culvert was found to be completely buried by sediment, so no stormwater that is discharged to the north of Route 28 is able to flow to Cockle Cove Creek.

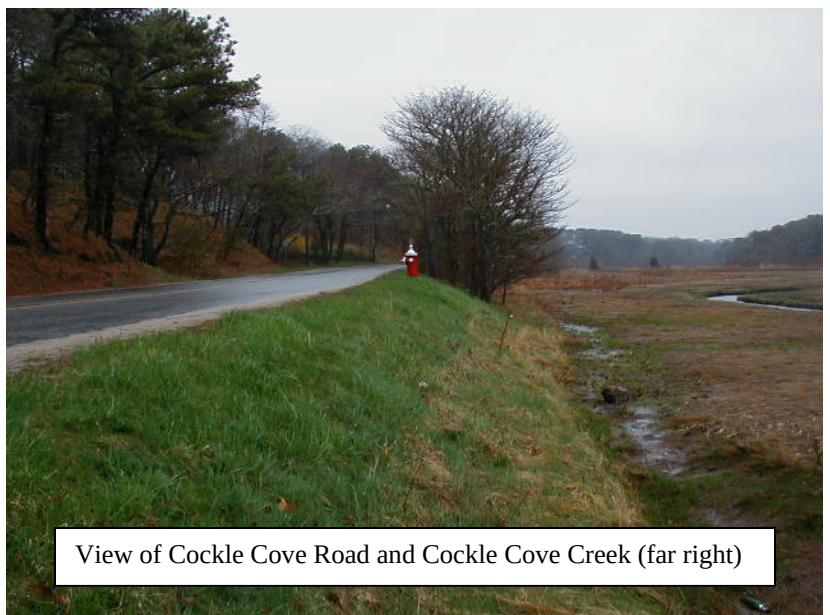
View of Cockle Cove Road and Cockle Cove Creek (far right)

In the majority of areas where stormwater runoff flows from the roadways to Cockle Cove Creek, there are long distances of vegetated land over which the stormwater travels before entering Cockle Cove Creek water (as shown at right). Decreased velocity of the runoff allows additional infiltration as the water travels over the vegetated land.

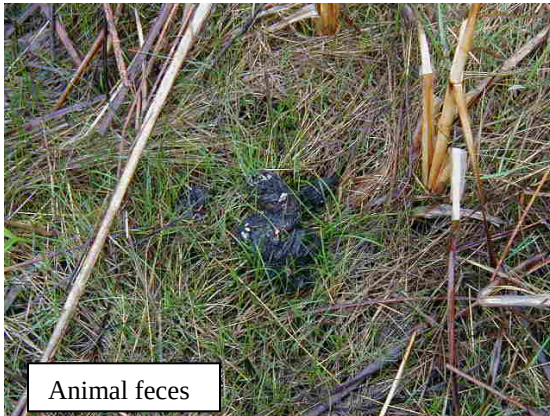
Although no significant stormwater point sources were evident, there were several natural enterococci sources evident on the initial site walk. Several piles of wildlife feces were observed on the marsh (see photo at left). There was also abundant evidence of wildlife living and eating in and around Cockle Cove Creek.

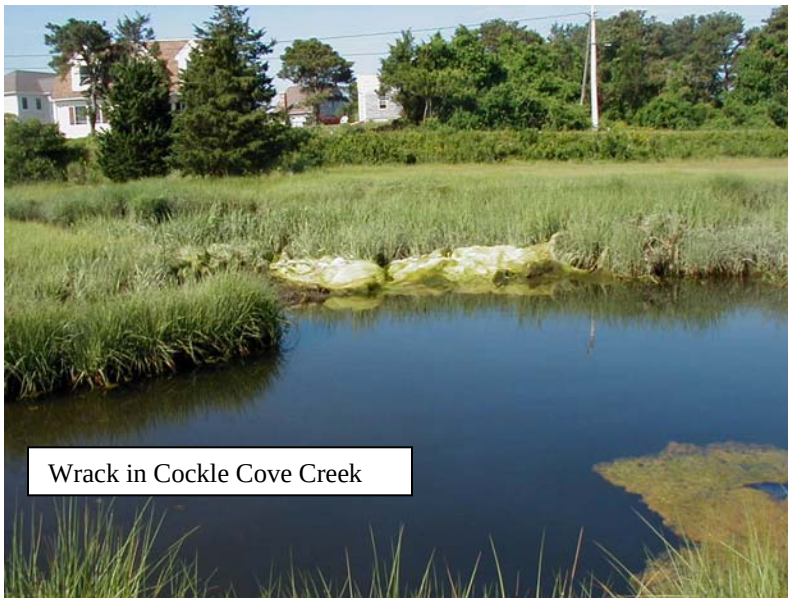
The July site walk again showed abundant evidence of wildlife activity. The marsh grass was quite tall, yet trails were worn down from the upland to the edge of Cockle Cove Creek; crab shells left by a predator were seen; and waterfowl were observed swimming in Cockle Cove Creek.

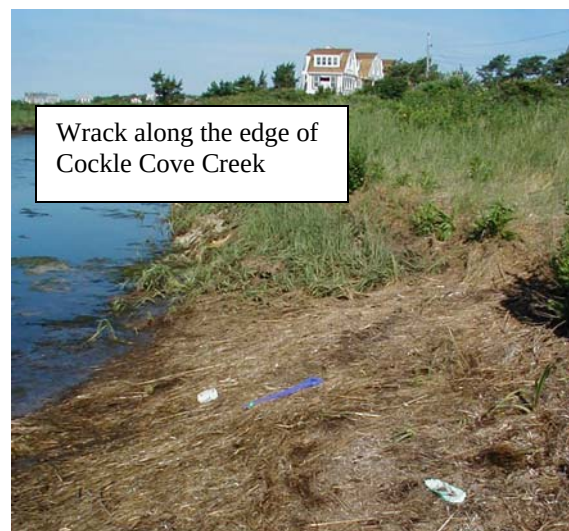
**5.5 Natural sources:** A variety of natural bacterial contamination sources were identified during the study. Abundant evidence of wildlife activity was seen during the site walks. As the animals travel through the marsh, they leave feces and food remnants (crab shells, etc.) in marsh grass and other areas close to the water's edge. During rain events or tidal movements, the debris can wash into the water and increase the bacterial counts.
